# PROPOSAL FOR SANITATION IMPROVEMENT IN ROHINGYA REFUGEE SETTLEMENTS IN JAMMU

Report Prepared for Development And Justice Initiative by Rahul Banerjee  
(rahul.indauri@gmail.com)

### Executive Summary

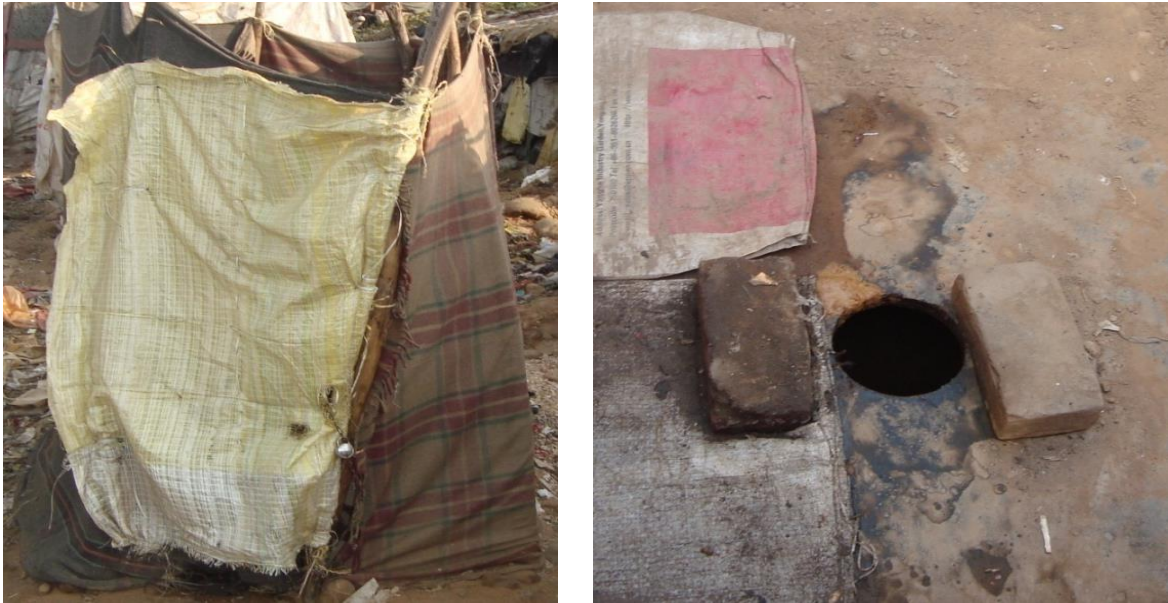
**Fig.2. Makeshift toilets in Refugee Settlements**

The lack of proper latrines is the main problem. While men go to the stream nearby for open defecation, women have to use makeshift toilets like the one shown in Fig. 2. Old metal, cardboard and plastic sheets are used to somehow cover the pit and this is very unhygienic. Even these toilets were few in number as compared to the population and so the women often have to defecate within their houses in plastic bags and then throw them away at night.

The refugee settlements of Jammu are ideally suited for a pit latrine solution since the people do not have money to implement more sophisticated solutions and neither do they have a good supply of water that is necessary for such solutions. They have also agreed to contribute the labour required for digging the pits and construct the makeshift superstructures from wood and plastic. Therefore, only the cost of the plastic drums, water sealed seat and removable cover and piping will have to be borne by the implementing agency. This cost in the case of individual household toilet systems made with 200 litre recycled plastic drums would be as low as Rs 6000. In some settlements there is a serious lack of space and so bigger latrines catering to 5 households each will have to be built and in such cases the cost will be Rs 15000 as new water tanks will have to be purchased for use as pits.

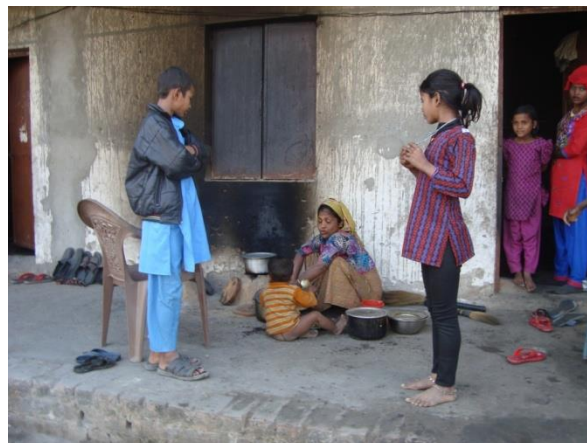
**Fig. 3. Brick and Concrete Quarters in TeliBasti**

The water supply is uncertain and inadequate. People have to store water in plastic drums. Anwar Maulvi the owner of the land on which the refugees are staying also participated in the group discussion. He was agreeable to the construction of pit latrines using plastic drums. He also said that water supply could be improved by the installation of a handpump. The refugees were prepared to contribute labour for the construction of toilets and requested especially that their precarious water supply situation also should be improved. The people here are mostly daily wage workers in the factories in the industrial area and have very low incomes. So they are not able to expend much on provision of amenities. Those few families that live in the brick and concrete buildings too do not have toilet facilities and live in congested quarters as shown in Fig. 3. below

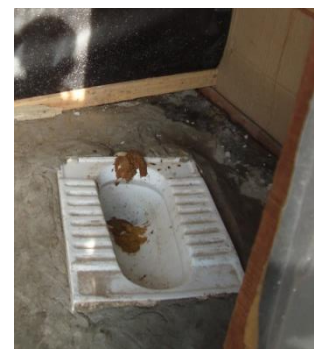
Fig.5. Toilet at Sunjwan

This settlement is located on a private plot at 32.697112N and 74.915282E and has 60 households. The focus group discussions with the men were led by Mushtaq Ahmed while those with the women were led by Dilara Begum. There is a Madrasa and Masjid campus in the middle which has a toilet with a proper seat. However, there is severe shortage of water which has to be bought from private water suppliers through tankers. That is why there is little water to flush the toilet and it remains dirty with faeces as shown in Fig. 5. The Muslim religious body which has funded the construction of the Masjid campus is prepared to arrange for a handpump also but the geo-hydrological characteristics of the area are such that water is available only in the hard rock at depths of 300 metres or more and that too without any surety and it will cost 8 lakhs. The people here agreed to contribute labour for the construction of toilets but like in the case of Marathi Mohalla were more concerned about the supply of water which was in severe short supply. Waste collection and recycling is the main occupation of the people here in addition to wage labour and the women are involved in the sorting operations. The women are shown in Fig.6. below.

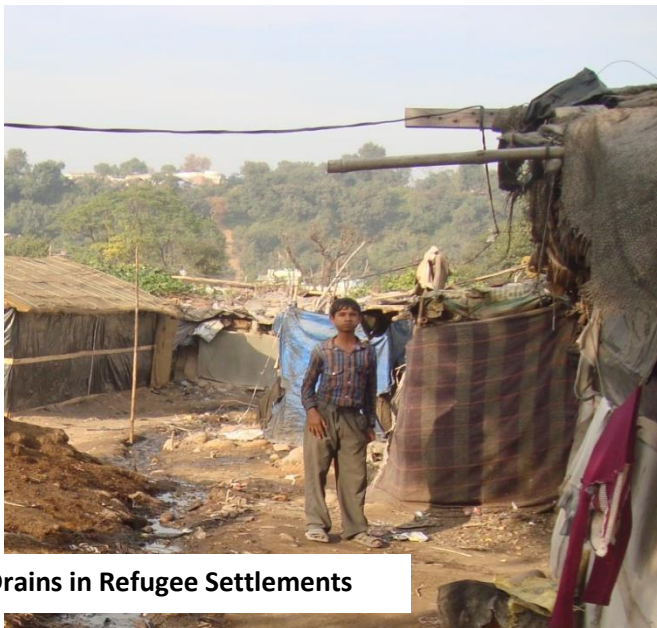
**Fig.7. Open Drains in Refugee Settlements**

This is the most congested and biggest settlement as 120 households are crammed into a small plot of about 1000 square metres. In addition to the usual problems of lack of water supply and toilets, the drainage problems are severe due to this congestion as the waste water from the bathrooms and cooking has nowhere to go and festers in between the huts as shown in Fig. 7. below.

The grey water from the kitchen and the bathroom which is currently festering in the open, can be directed into a soak pit filled with brick crush and sand next to the huts and this will effectively remove

the unhygienic conditions resulting from dead ended open drains. This would cost about Rs 3000 for individual households and Rs 7500 for a five household system. All these alternatives with their specifications and cost estimates have been summarised in Table 1 below.

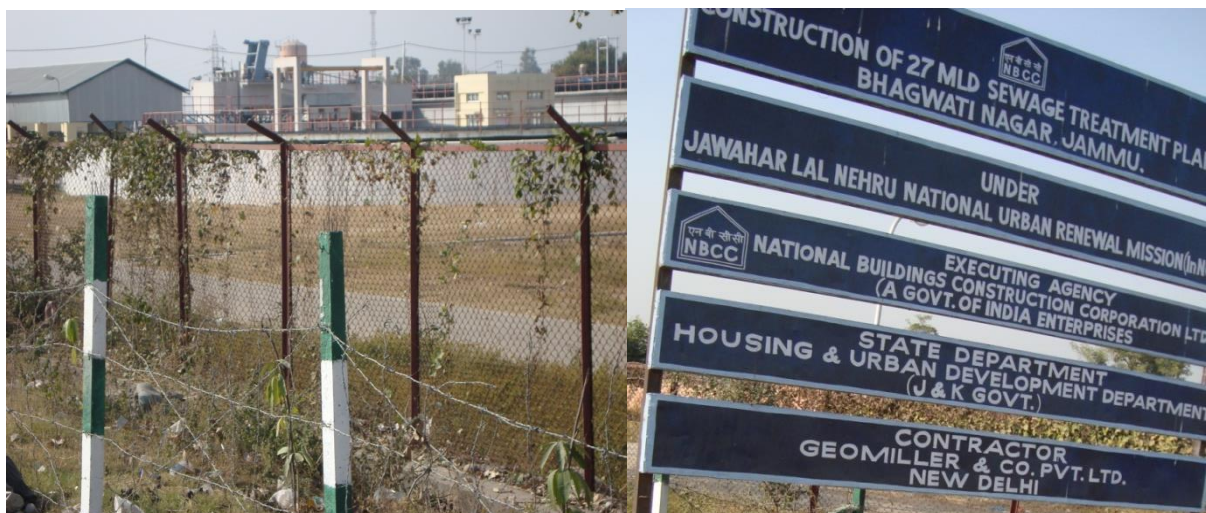
Fig.8. Sewage Treatment Plant in Jammu lying idle

Sanitation in urban areas is a problem throughout India. Primarily because centralised treatment of wastewater requires huge capital investments in treatment plants and sewerage followed by substantial recurring operation costs. Urban local bodies are rarely able to garner the resources for this from the citizens through user charges. Consequently, in all urban areas in the country including the capital Delhi a considerable amount of waste water gets released into the environment untreated causing serious pollution (CSE, 2013). In Jammu city also two sewage treatment plants have been constructed but they are not functional as shown in Fig. 8. below and all the wastewater of the city is flowing untreated into the Tawi River and polluting it (Bhagat et al, 2014).

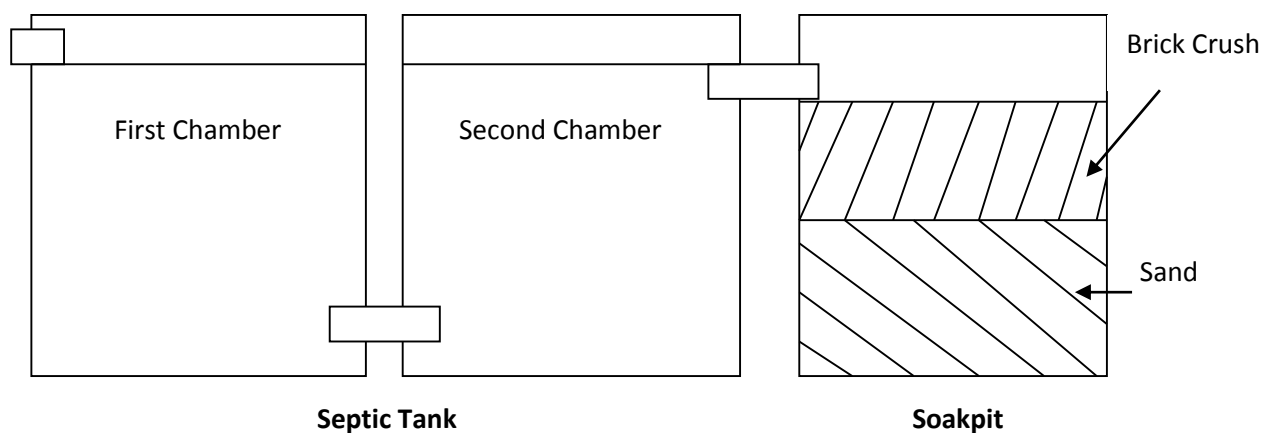
**Fig. 10. Septic Tank and Soakpit System**

There are a few other slightly costlier solutions which are better as far as control of pollution is concerned though they give the same level of hygiene. The first is the installation of a septic tank cum soakpit system where the effluent instead of leaching directly into the ground is treated in a two chamber septic tank constructed of plastic tanks and pipes and then this treated water is routed through a soak pit consisting of brick crush and sand contained in a perforated plastic tank into the ground. In this case the cost will be about Rs 10000 for an individual latrine system and Rs 20000 for a five household one. A diagram of a septic tank cum soakpit system is shown in Fig. 10 below.

The second alternative which is feasible only for the five household system is to insert air into the second chamber of the septic tank system through a bubble diffuser attached to a vacuum pump outlet which runs intermittently for an hour and stops for an hour through the use of an electronic relay. The use of aerobic digestion ensures a better and faster digestion of the sludge and also avoids the generation of foul smelling gases. Where there is space the outlet water from the aerated septic tank can be used for producing vegetables in kitchen gardens. This system will cost Rs 25000 to install and it will require about Rs 100 in electricity costs per month to run apart from repair costs of the pump once every year to replace the diaphragm.
